Prepared by:

Company Name: Haven Home Inspections LLC

2023-05-23

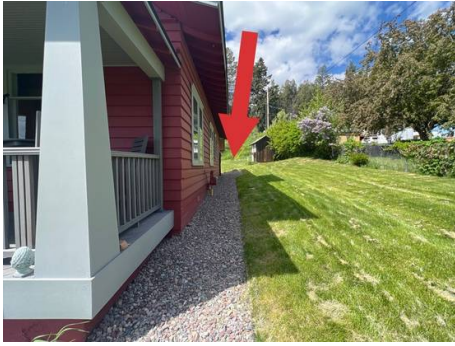
Grading had negative slope in some areas close to home and water could pool against the foundation or cause moisture intrusion

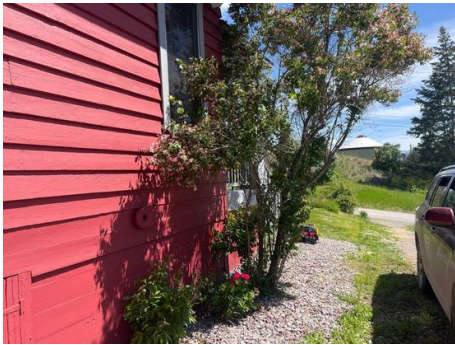
Recommend keeping vegetation away from the structure(s)

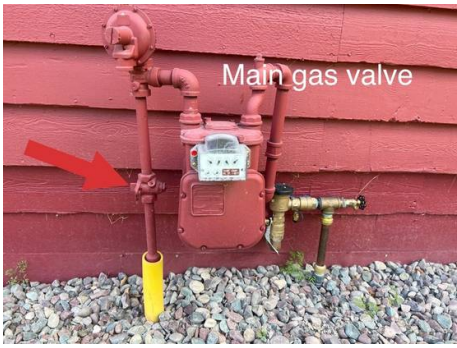
Location: North exterior.

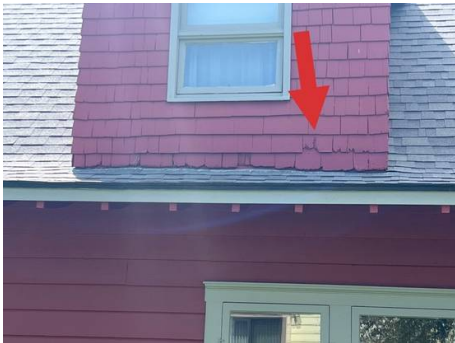
Surface damage noted

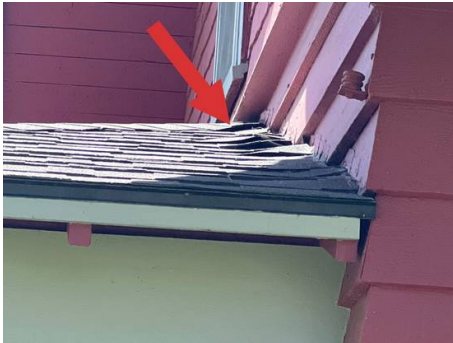
Loose or damaged shingles were noted. Recommend repair.

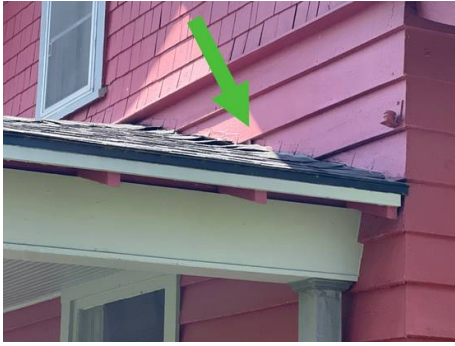
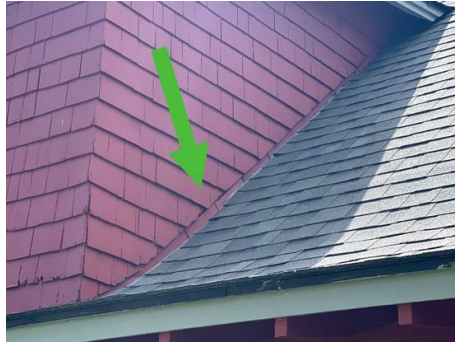
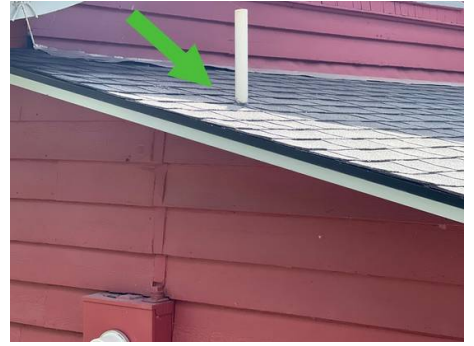
Flashings are incorrectly installed and do not fully serve their intended purpose. We recommend repair or replacement to prevent leakage.

Missing flashing was noted

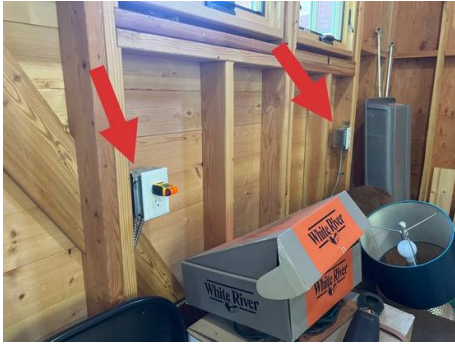
This structure is a rudimentary structure and built more like a shed or barn type structure. There's no roof sheathing, wall sheathing, or roof moisture barrier. The siding and roof shingles are attached directly to the framing. This will allow some moisture penetration during rain.

NO GFCI: see GFCI comments under electrical section.

Recommend adding exterior receptacle covers due to the construction of the garage. Water can get in through the roof and siding.

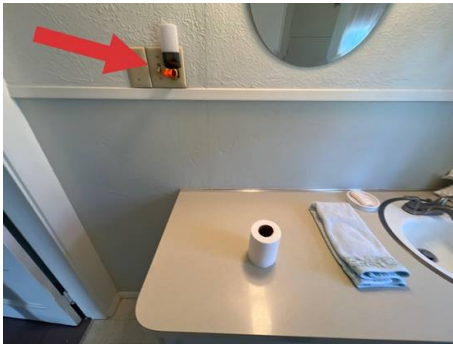
Non-GFCI outlets, near water source. Potential safety hazard.

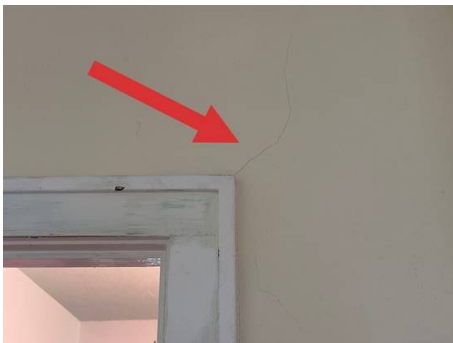
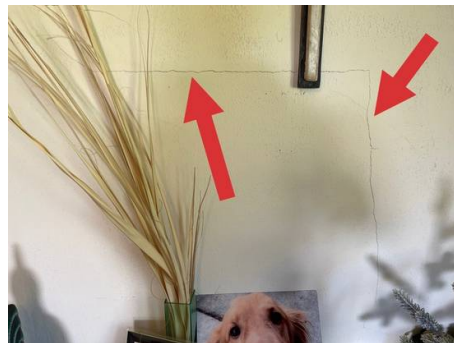
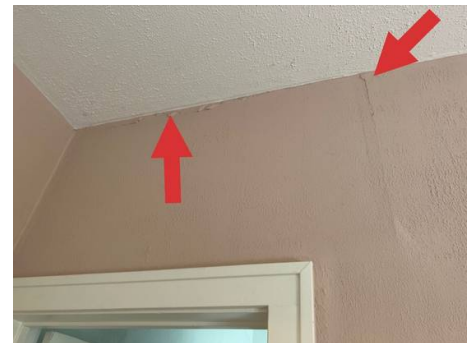
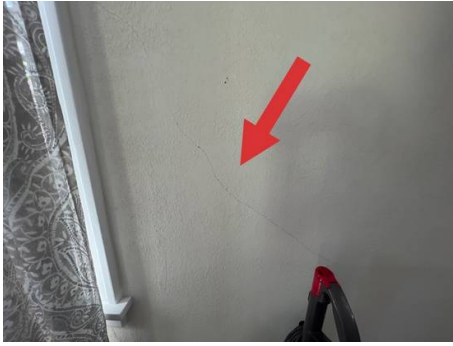
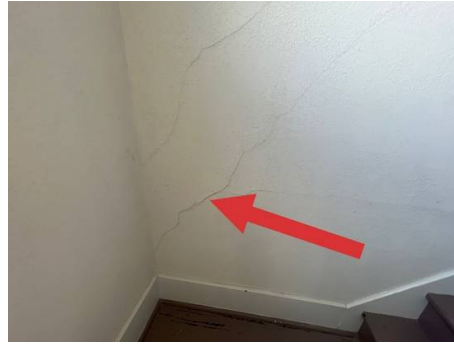
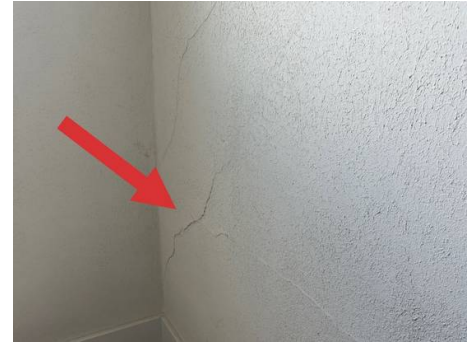
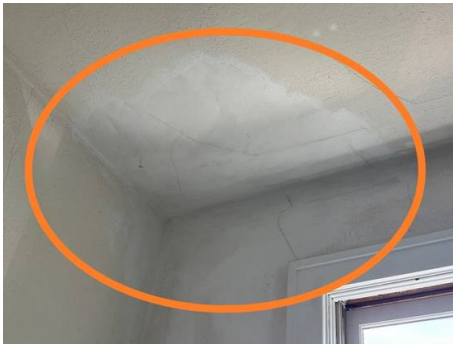
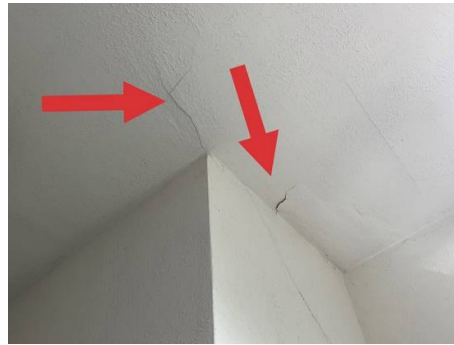
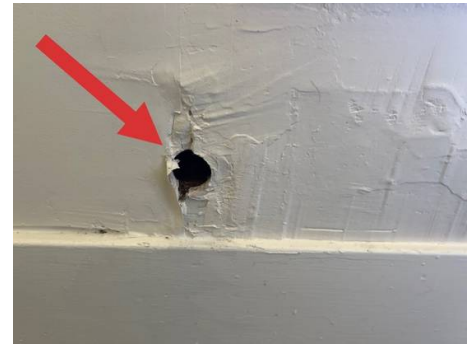
Cracks were noted over multiple doors and/or windows throughout the home. Cracks are normally caused by movement and/or thermal expansion/contraction within the home. Unable to determine the cause of the cracks at the time of the inspection. Repair and continual monitoring are recommended. Have a qualified contractor further evaluate and repair.

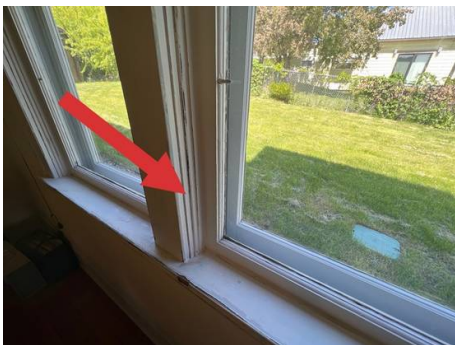
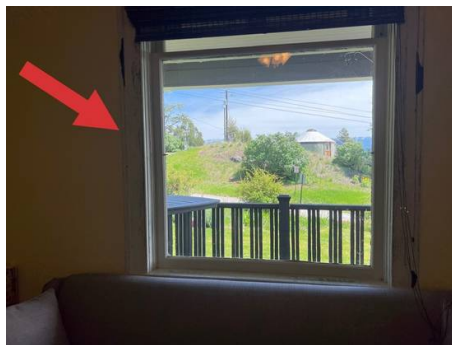
Several windows were painted shut or hard to operate on the tracks. Recommend scraping paint off tracks and repairing as necessary.

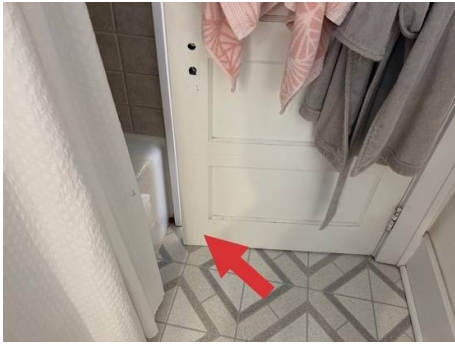
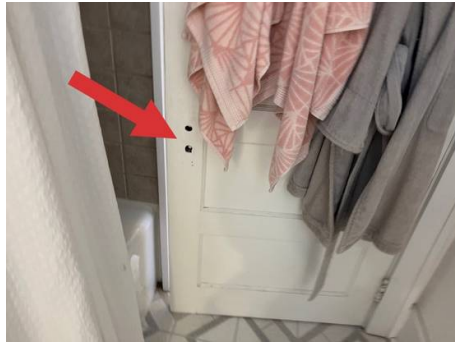
Missing handles noted.

Doors rubbing on floor during operation. Signs of settlement.

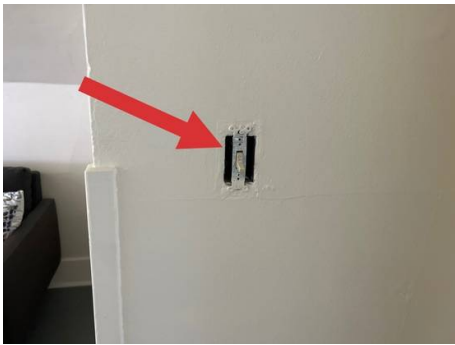
Missing switch plates. Recommend replacing for added safety.

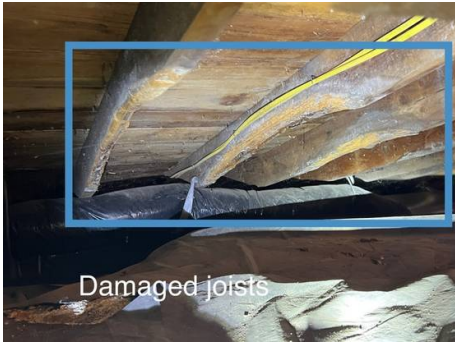
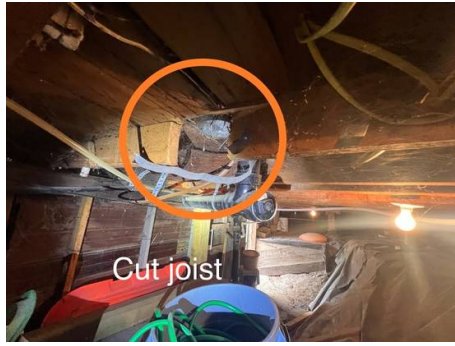
Wood rot and damage noted at joists along north side. Recommend evaluation by a qualified contractor.

Altered joists were present and appeared to be compromised. Recommend evaluation by a qualified contractor.

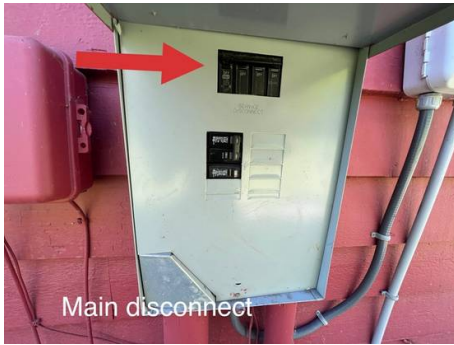
Underground service entry noted, 120/240 Volts supplied by the utility

200 Amp

Square D

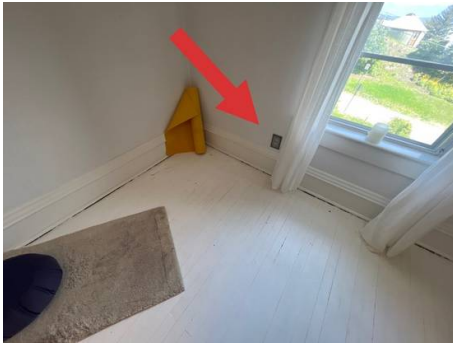
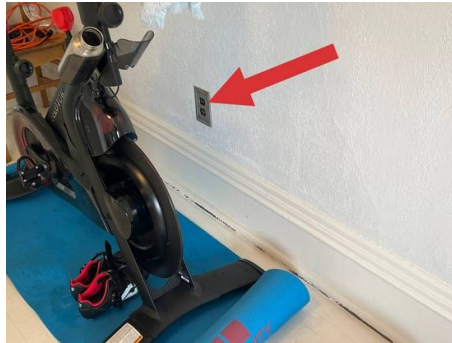
Some outlets were inoperable at the time of inspection. Repair as necessary. Upstairs East bedroom.

GFCI protected receptacles may not have been required when the house was built. We suggest buyer consider upgrading with GFCI's at all receptacles near water sources, bathrooms, laundry rooms, kitchen countertops, exterior, basement or crawl spaces, and garages/shops.

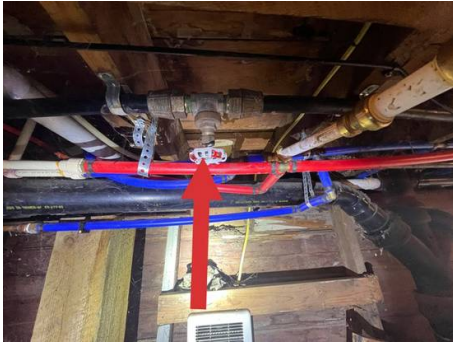
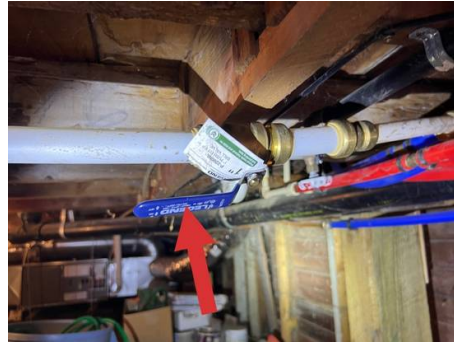
One of these valves is likely your main shut off and the other is to your exterior hose bib. Test them both to see what they operate. It appears the blue levered valve is to the exterior hose bib.

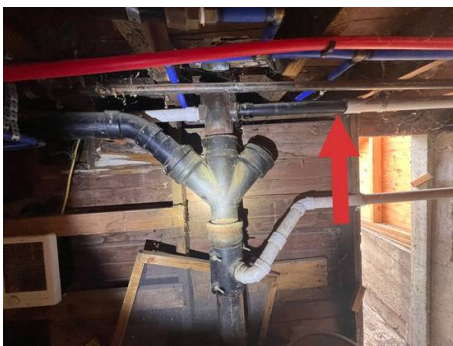
ABS PVC plastic piping have been linked in the drain system. Unless proper sealants were employed, leakage is possible at the juncture. No leakage was observed at the time of inspection.

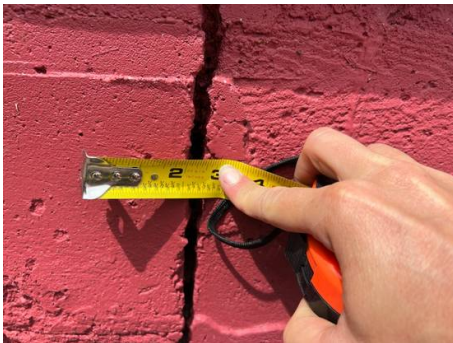
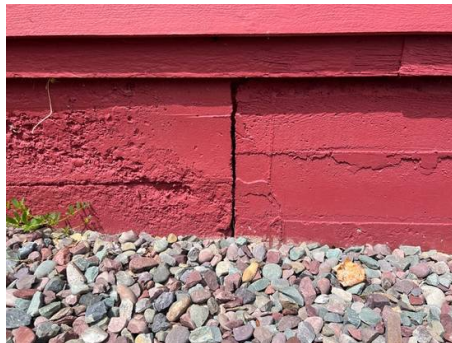
Cracks in the foundation large enough to be structurally significant were noted. The foundation of your home is one of the most important structural features, and the cracks that were noted could be indicative of a larger issue. Recommend evaluation by a qualified foundation contractor.

Not accessible for inspection due to wood panel cover.

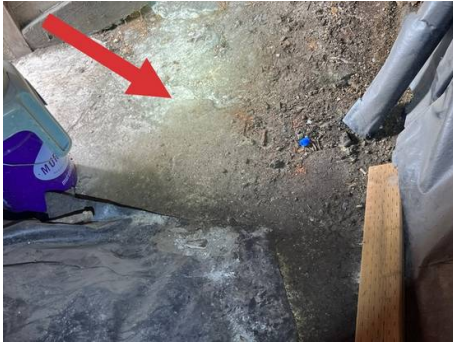
Vapor barrier not continuous. Recommend covering all the bare dirt floor with a vapor barrier.

Dirt floor noted.

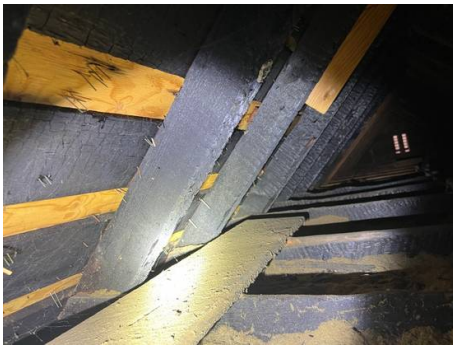
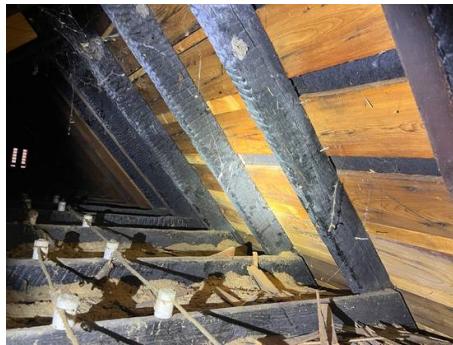
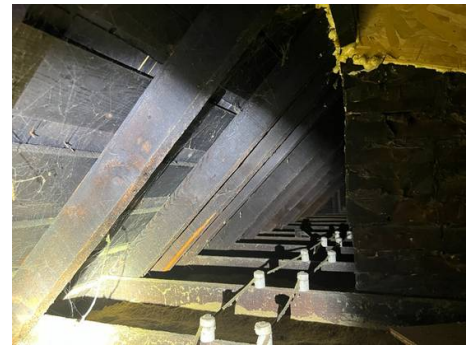
Damaged and burnt roof framing was noted from a past fire. Recommend evaluation by a qualified contractor.
